SIX STEPS THAT DOOMED THE RIG

The blowout of BP's Macondo oil well on April 20 was the result of a string of five human errors and one final, colossal mechanical failure, when the blowout preventer failed to close off the exploding well. The choices were made in the final hours before the exploratory well was to be completed and the Deepwater Horizon removed. BP engineers knew they had an especially tough well, but repeatedly made quicker, cheaper and ultimately more dangerous choices. They seemed to consider each danger in a vacuum, never thinking they could all add up to 11 dead rig workers, a sunken rig and millions of barrels of crude fouling the Gulf.

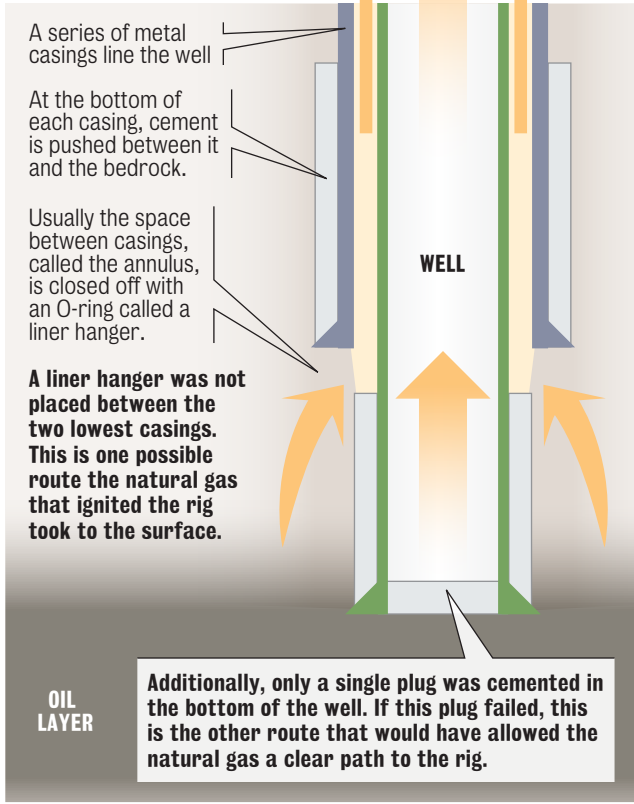
THE BP METHOD:

1 FEWER BARRIERS TO GAS FLOW

BP had two choices of how to line the well with metal tubes and cement seals. Its engineers considered using a typical industry practice of a short liner at the bottom, with additional seals. But they ultimately chose a method that saved the company up to \$10 million.

BP used a single, long string of casing in the middle of the hole, one designed for later use in extracting oil. That created an open space along the sides and fewer plugs in the center.

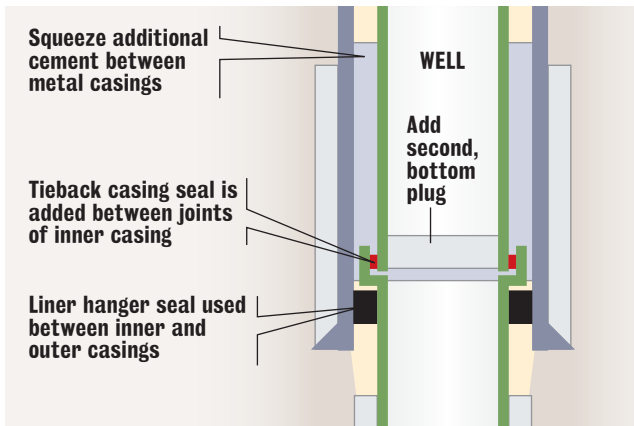
A BETTER WAY:

Common industry practice is to use a shorter tube called a "liner" at the bottom of the hole, then a separate tool called a tie-back. These would have created an additional barrier, as well as the addition of a second plug in the middle of the well, but it would have cost millions of dollars more and BP chose not to do it.

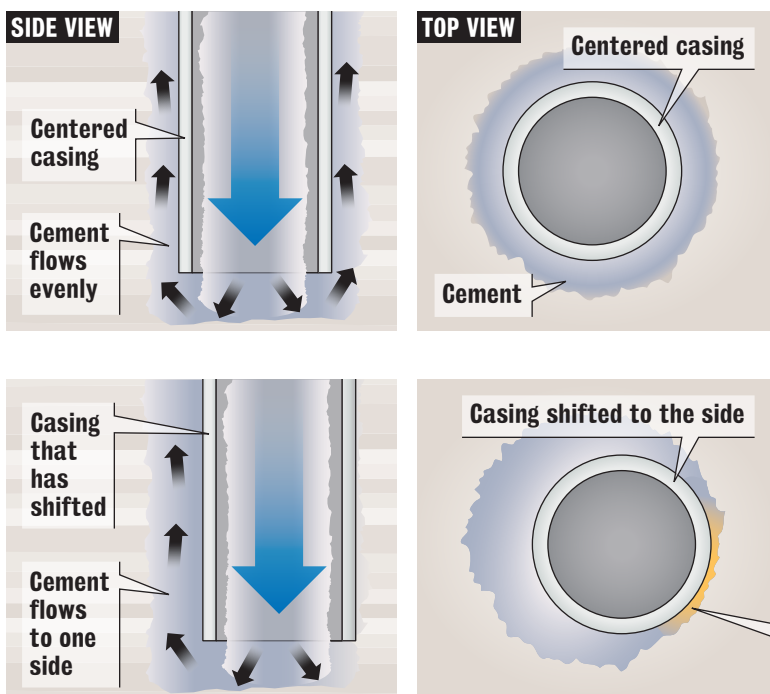
2 FEWER CENTRALIZERS TO KEEP CEMENT EVEN

BP chose to use six of the devices for keeping tubes centered, ignoring Halliburton models calling for 21. It's important to have the telescoping tubes centered in the hole because that's where cement is poured. If a tube is sitting to one side, the cement slurry will follow the path of least resistance and set unevenly, leaving weak points where gas could seep in.

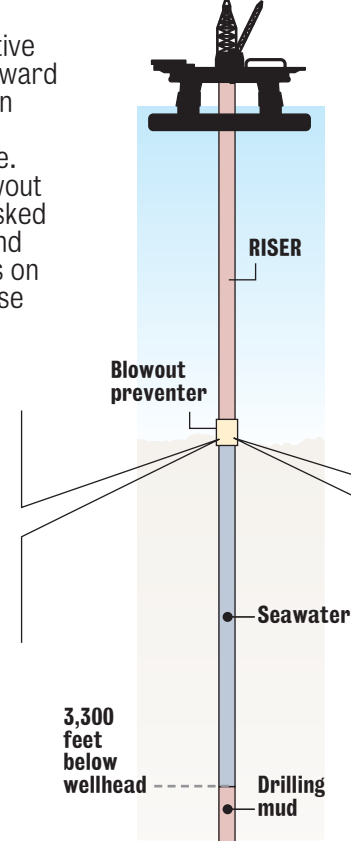
4 PRESSURE TEST MISINTERPRETED

Rig workers reported confusion over the negative test, which measures upward pressure from the shut-in well. It is a key test of whether the well is stable. Material used in the blowout preventer may have masked the test's true results, and heavy pressure readings on the drill pipe failed to raise red flags.

DOUBLE AMOUNT OF SPACER FLUID ADDED:

An extra dose of heavy fluid called spacer is pumped into the blowout preventer so BP won't have to pay to dispose of it. The higher density of the additional spacer may have obscured key test readings.

FIRST PRESSURE TEST:

A valve is closed on the blowout preventer to pressurize the drill pipe for testing. During the test 15 barrels of drilling mud leak from the valve. The mud was a sign that there was gas pressure in the well.

SECOND PRESSURE TEST:

Another test is run with more pressure on the blowout preventer valve. No mud escapes during the second test, which is deemed a success. But 1,400 pounds per square inch of pressure is recorded on the drill pipe when it should have been zero. That red flag was dismissed.

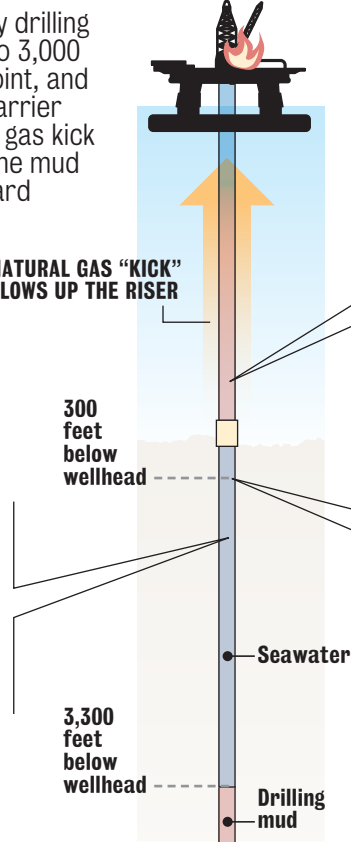
5 MUD BARRIER REMOVED EARLY

BP decided to take heavy drilling mud out of the system, to 3,000 feet below the normal point, and earlier than usual. The barrier wasn't there to stem the gas kick that destroyed the rig. The mud is used to keep any upward pressure under control.

SEAWATER BELOW BLOWOUT PREVENTER NOT HEAVY ENOUGH:

The larger amount of seawater left below the BOP from the pressure tests is not as good a barrier when the well experiences a natural gas "kick."

MUD IN THE RISER WAS BEING REPLACED WHEN RIG EXPLODED:

Lighter seawater was being put into the riser as the Deepwater Horizon was preparing to disconnect from the well. The pumping of the oil from the drilled well was to be handled by a production platform or pipeline.

BETTER WAY ESCHEWED:

BP engineers actually had a fallback plan to use the industry-standard 300 feet of seawater in the well, and to set a final top plug before removing mud from the riser. But federal regulators allowed them to use the quicker way.

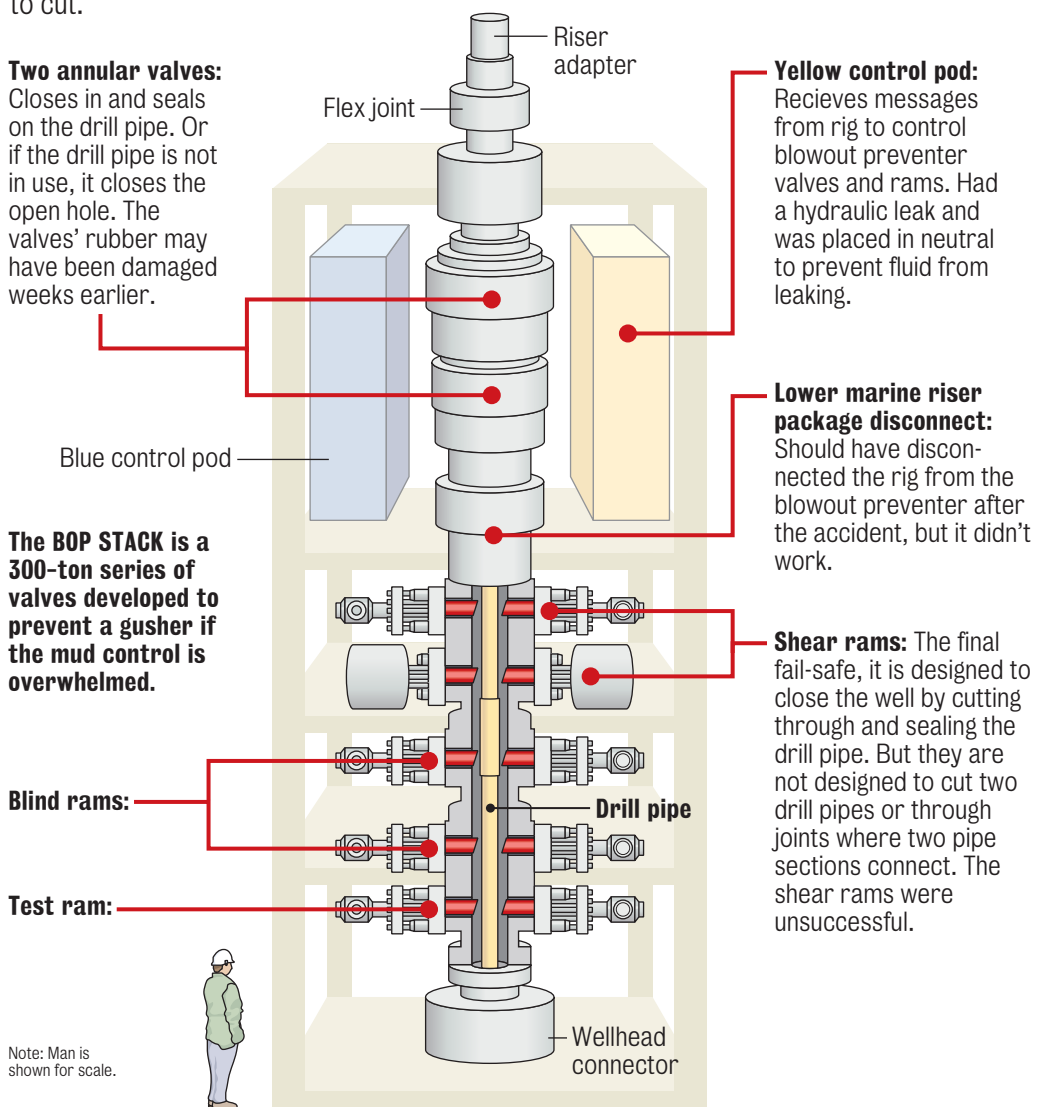
6 BLOWOUT PREVENTER FAILED

It's unclear exactly why, but the last line of defense to close in the well never worked. A hydraulic leak could have been the culprit, or a plumbing issue, or debris could have fouled it up, or there may have been more pipes running through it than it was designed to cut.

Two annular valves:

Closes in and seals on the drill pipe. Or if the drill pipe is not in use, it closes the open hole. The valves' rubber may have been damaged weeks earlier.

Yellow control pod:

Receives messages from rig to control blowout preventer valves and rams. Had a hydraulic leak and was placed in neutral to prevent fluid from leaking.

Lower marine riser package disconnect:

Should have disconnected the rig from the blowout preventer after the accident, but it didn't work.

Shear rams:

The final fail-safe, it is designed to close the well by cutting through and sealing the drill pipe. But they are not designed to cut two drill pipes or through joints where two pipe sections connect. The shear rams were unsuccessful.
